**VOLUNTARY CLEANUP COMPLETION REPORT
FOR THE
SILVER SWAN MINE AREA
RICO, COLORADO**

**Voluntary Cleanup Completion Report
for the
Silver Swan Mine Area
Rico, Colorado**

RECLAMATION MONITORING RESULTS FOR THE SILVER SWAN MINE

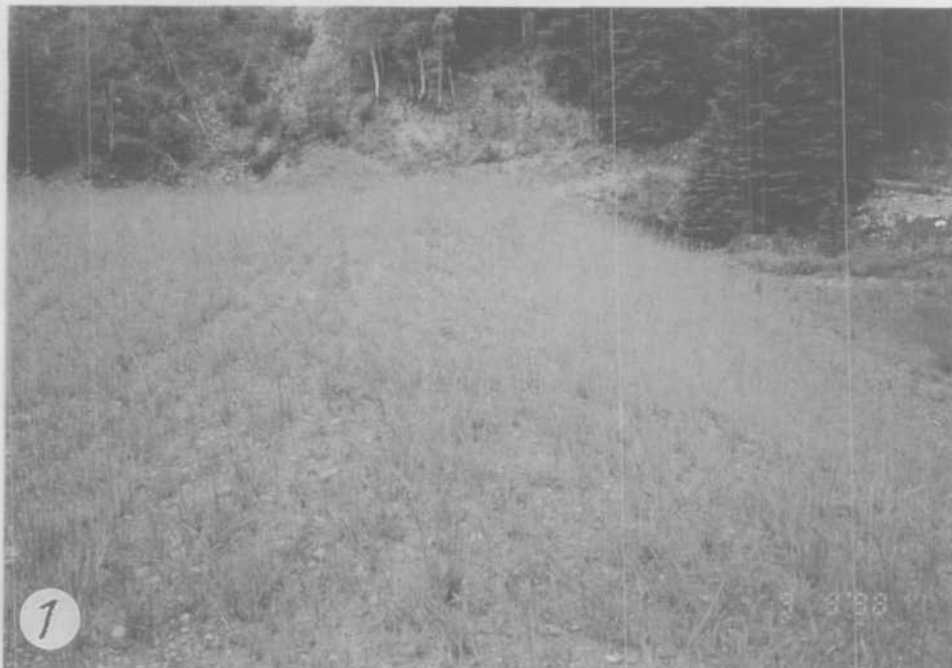
Photo #	Description
1	Looking west-southwest across the north top and north slope of the revegetated waste pile.
2	Looking north-northwest across the wetlands near the northern border of the project area.
